Pure Lead Products (former), Miami, Miami-Dade County, FL, Wednesday, May 19, 2010, from about 9 am 10 am. Inspection by Hubert Philoctete and Paul Wierzbicki. Photo taken by Paul Wierzbicki. 46 photos taken with Waste Cleanup Olympus Digital Camera. Met Philip Cook, P.G. and Mr. Jeff Hooper on site. Mr. Hooper had the key to the gate. Outside of main gate to 3460 NW North River Drive facility looking southeast. Note active railroad tracks, gravel and broken asphalt in this area. Photo 1 of 46.

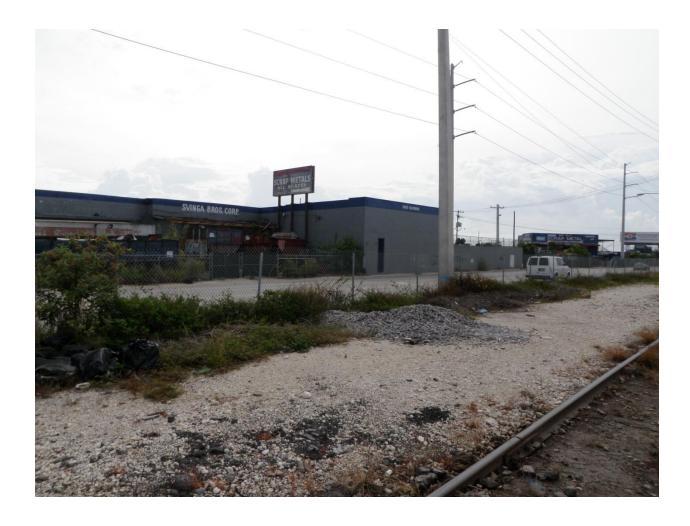
Pure Lead Products (former), Miami, Miami-Dade County, FL, Wednesday, May 19, 2010, from about 9 am 10 am. Inspection by Hubert Philoctete and Paul Wierzbicki. Photo taken by Paul Wierzbicki. 46 photos taken with Waste Cleanup Olympus Digital Camera. Met Philip Cook, P.G. and Mr. Jeff Hooper on site. Mr. Hooper had the key to the gate. Photo taken looking Southeast from 3460 NW North River Dr. Note Power lines, railroad tracks and road right of way and surrounding facilities. Photo 2 of 46.

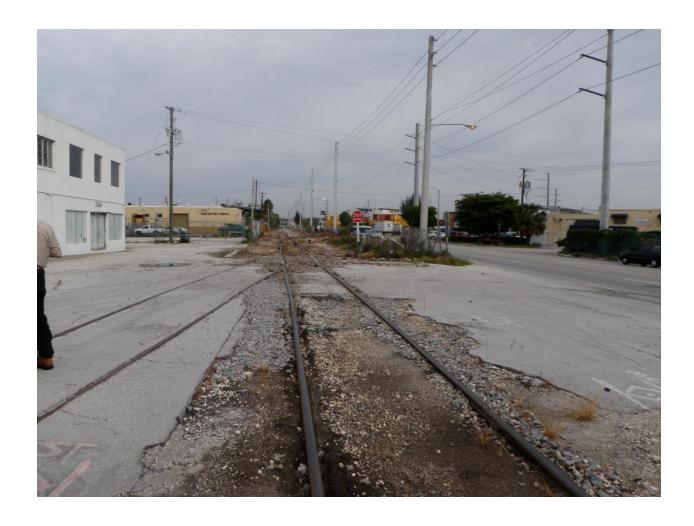
Pure Lead Products (former), Miami, Miami-Dade County, FL, Wednesday, May 19, 2010, from about 9 am 10 am. Inspection by Hubert Philoctete and Paul Wierzbicki. Photo taken by Paul Wierzbicki. 46 photos taken with Waste Cleanup Olympus Digital Camera. Met Philip Cook, P.G. and Mr. Jeff Hooper on site. Mr. Hooper had the key to the gate. Looking Northwest from front of 3460 NW North Rivers Drive. Note active railroad line and unused spur line that used to serve the Pure Lead Products facility and adjacent operation. Photo 3 of 46.

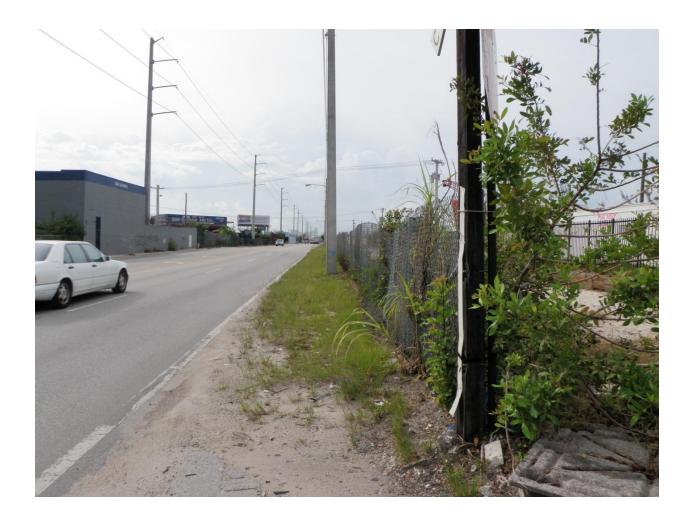
Pure Lead Products (former), Miami, Miami-Dade County, FL, Wednesday, May 19, 2010, from about 9 am 10 am. Inspection by Hubert Philoctete and Paul Wierzbicki. Photo taken by Paul Wierzbicki. 46 photos taken with Waste Cleanup Olympus Digital Camera. Looking Southeast from 3460 NW North River Drive along the South Side of NW North River Dr. Note clearances between fence, road right of way, and power lines. Pure Lead Facility is on the right side of photo in the distance. Photo 4 of 46.

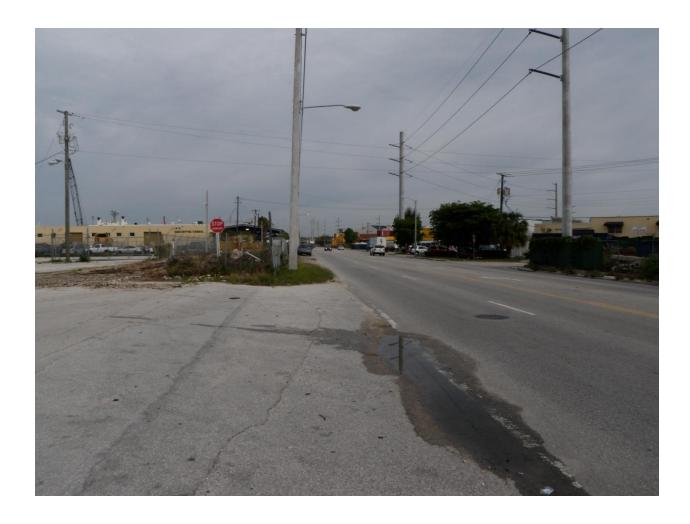
Pure Lead Products (former), Miami, Miami-Dade County, FL, Wednesday, May 19, 2010, from about 9 am 10 am. Inspection by Hubert Philoctete and Paul Wierzbicki. Photo taken by Paul Wierzbicki. 46 photos taken with Waste Cleanup Olympus Digital Camera. Looking NW from 3460 NW North River Drive. Note driveway, railroad tracks and spacing between road right of way, power lines and facility. Photo 5 of 46.

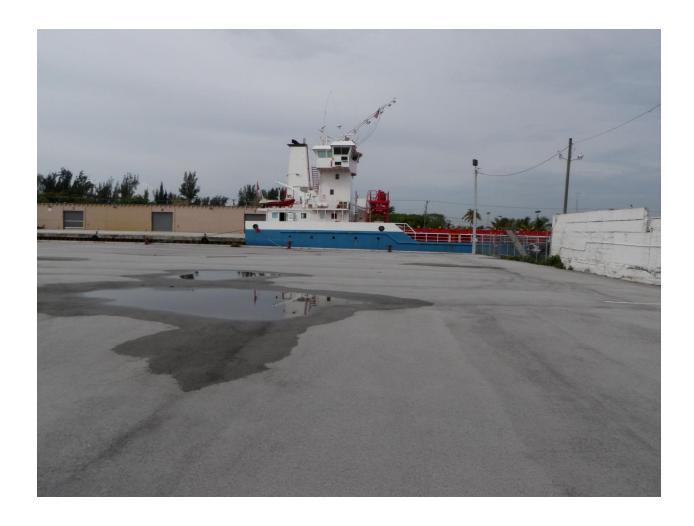
Pure Lead Products (former), Miami, Miami-Dade County, FL, Wednesday, May 19, 2010, from about 9 am 10 am. Inspection by Hubert Philoctete and Paul Wierzbicki. Photo taken by Paul Wierzbicki. 46 photos taken with Waste Cleanup Olympus Digital Camera. Met Philip Cook, P.G. and Mr. Jeff Hooper on site. Mr. Hooper had the key to the gate. Looking South toward the Miami River and parked vessel at the river bank. Looking from the entrance of 3460 NW North River Dr. Note pavement. Photo 6 of 46.

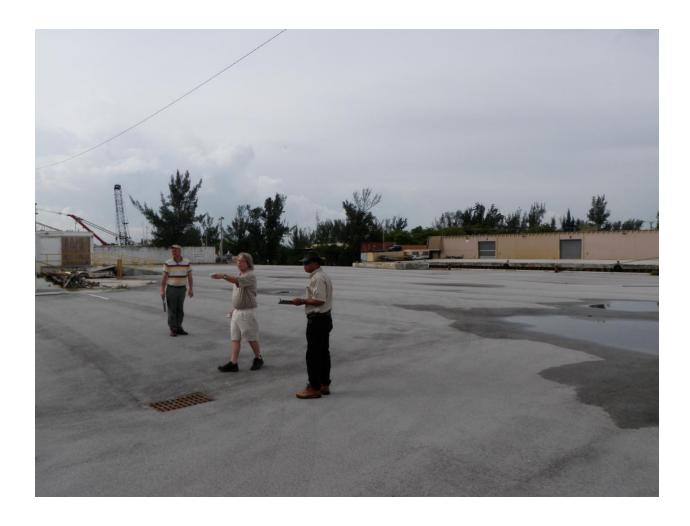
Pure Lead Products (former), Miami, Miami-Dade County, FL, Wednesday, May 19, 2010, from about 9 am 10 am. Inspection by Hubert Philoctete and Paul Wierzbicki. Photo taken by Paul Wierzbicki. 46 photos taken with Waste Cleanup Olympus Digital Camera. Looking due South / Southeast from 3460 NW North River Drive toward the Miami River. Note Storm Drain and pavement. Note also the accumulated Solid Waste in the background. Large crane belongs to the 3440 NW North River Drive. Phil Cook, Mr. Hooper and Mr. Philoctete. Photo 7 of 46.

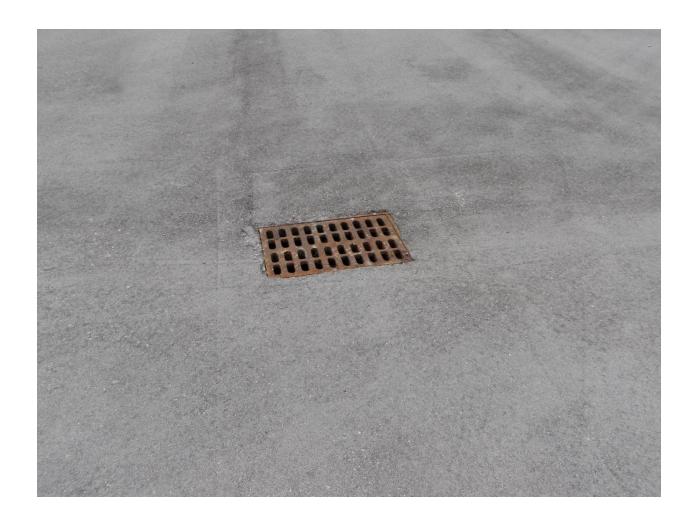
Pure Lead Products (former), Miami, Miami-Dade County, FL, Wednesday, May 19, 2010, from about 9 am 10 am. Inspection by Hubert Philoctete and Paul Wierzbicki. Photo taken by Paul Wierzbicki. 46 photos taken with Waste Cleanup Olympus Digital Camera. Close-up of storm drain near gate entrance to 3460 NW North River Drive. Photo 8 of 46.

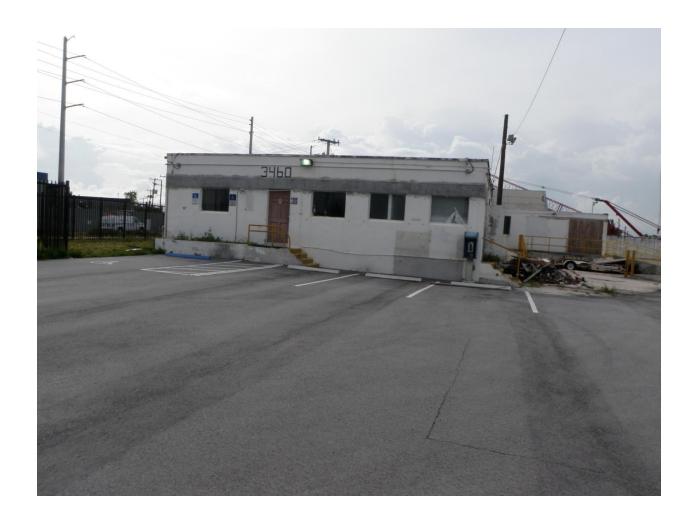
Pure Lead Products (former), Miami, Miami-Dade County, FL, Wednesday, May 19, 2010, from about 9 am 10 am. Inspection by Hubert Philoctete and Paul Wierzbicki. Photo taken by Paul Wierzbicki. 46 photos taken with Waste Cleanup Olympus Digital Camera. Vacant building at 3460 NW North River Dr. Note accumulated pile of Solid Waste at right of building. Mr. Hooper explained it was a "Cement Plant". Photo 9 of 46.

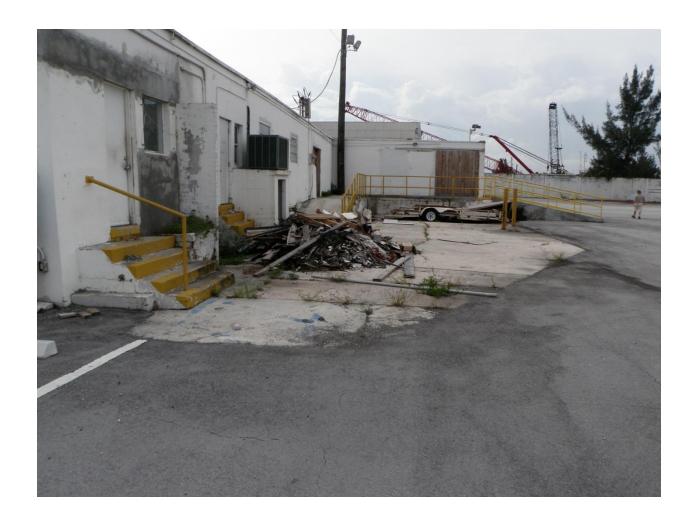
Pure Lead Products (former), Miami, Miami-Dade County, FL, Wednesday, May 19, 2010, from about 9 am 10 am. Inspection by Hubert Philoctete and Paul Wierzbicki. Photo taken by Paul Wierzbicki. 46 photos taken with Waste Cleanup Olympus Digital Camera. Note accumulated Solid Waste on right side (SW) Side of vacant Building at 3460 NW North River Drive on a concrete pad. Photo 10 of 46.

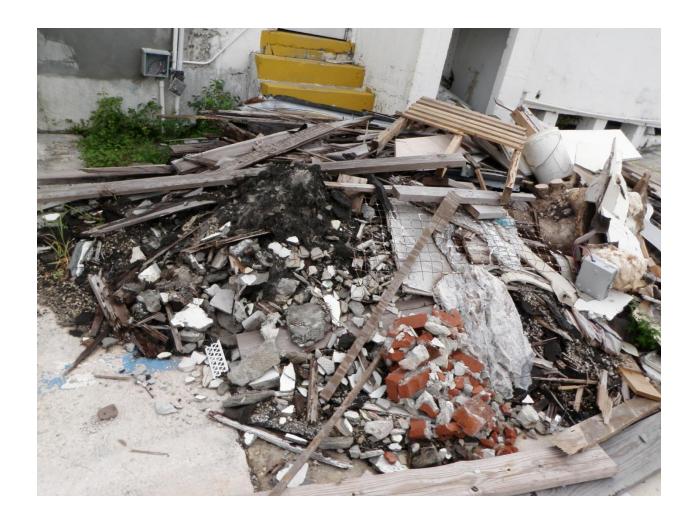
Pure Lead Products (former), Miami, Miami-Dade County, FL, Wednesday, May 19, 2010, from about 9 am 10 am. Inspection by Hubert Philoctete and Paul Wierzbicki. Photo taken by Paul Wierzbicki. 46 photos taken with Waste Cleanup Olympus Digital Camera. Close up of accumulated Solid Waste at vacant building located at 3460 NW North River Drive. Note accumulated bricks, plastics, roofing and building materials, wood pallets, containers, and other wood and debris. Photo 11 of 46.

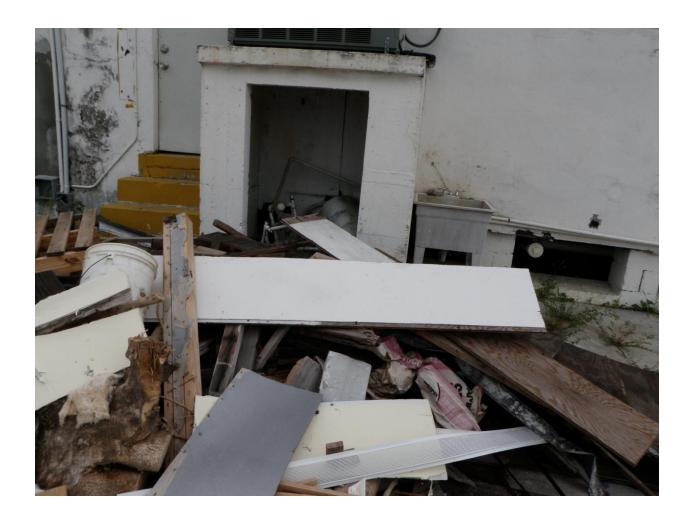
Pure Lead Products (former), Miami, Miami-Dade County, FL, Wednesday, May 19, 2010, from about 9 am 10 am. Inspection by Hubert Philoctete and Paul Wierzbicki. Photo taken by Paul Wierzbicki. 46 photos taken with Waste Cleanup Olympus Digital Camera. Met Philip Cook, P.G. and Mr. Jeff Hooper on site. Close up view of accumulated solid waste on Southwest side of building at 3460 NW North River Drive. Note 5-gallon container and another approximately 30 gallon container inside open storage room in the upper center of photo. Additionally, note the outdoor sink with unknown drainage. Accumulated debris made close inspection not possible. Photo 12 of 46.

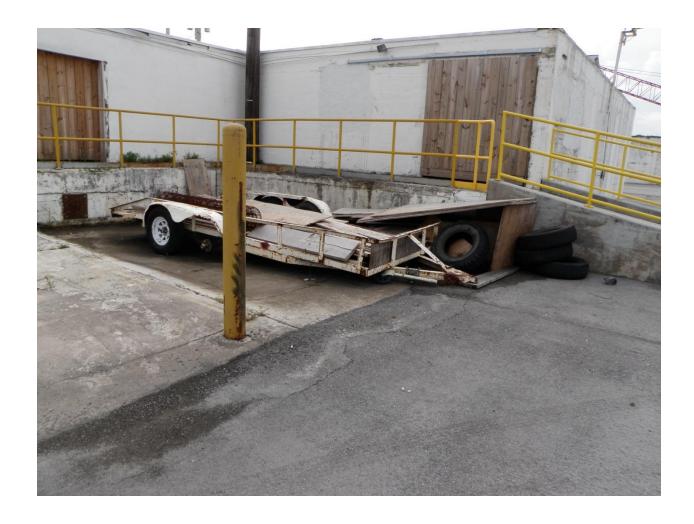
Pure Lead Products (former), Miami, Miami-Dade County, FL, Wednesday, May 19, 2010, from about 9 am 10 am. Inspection by Hubert Philoctete and Paul Wierzbicki. Photo taken by Paul Wierzbicki. 46 photos taken with Waste Cleanup Olympus Digital Camera. Met Philip Cook, P.G. and Mr. Jeff Hooper on site. Abandoned trailer and approximately 5 used tires located on southwestern side of the building at 3460 NW North River Dr. Photo 13 of 46.

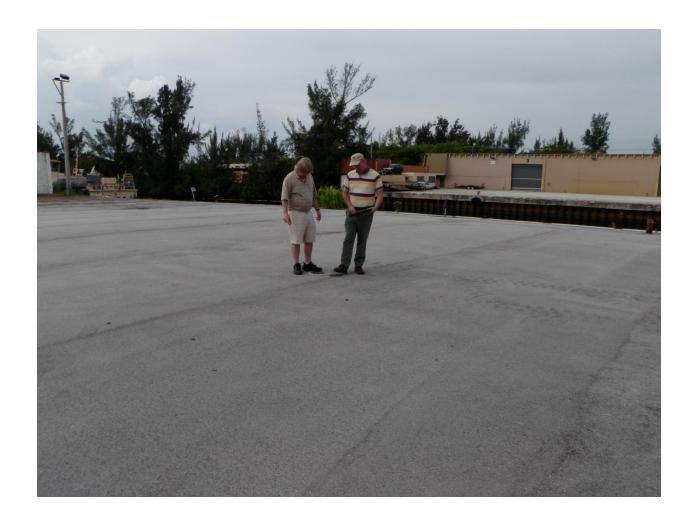
Pure Lead Products (former), Miami, Miami-Dade County, FL, Wednesday, May 19, 2010, from about 9 am 10 am. Inspection by Hubert Philoctete and Paul Wierzbicki. Photo taken by Paul Wierzbicki. 46 photos taken with Waste Cleanup Olympus Digital Camera. Met Philip Cook, P.G. and Mr. Jeff Hooper on site. Photo looking Southwest from 3460 NW North River Drive address toward Miami River. Note Storm drains beyond Mr. Hooper / Mr. Cook and in the upper left portion of photo. Photo 14 of 46.

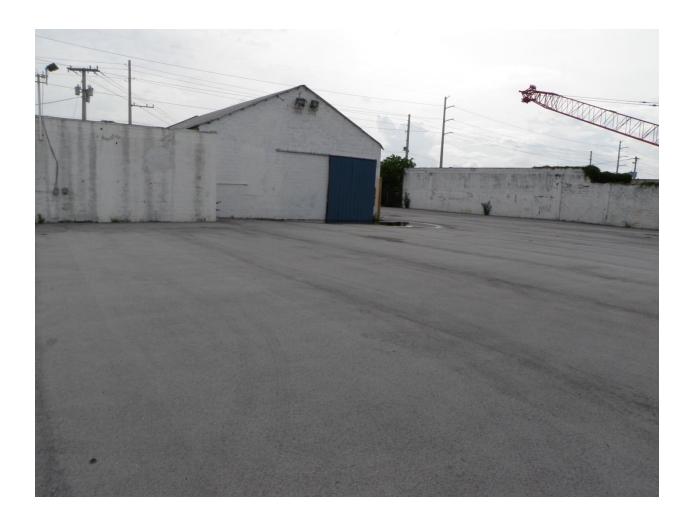
Pure Lead Products (former), Miami, Miami-Dade County, FL, Wednesday, May 19, 2010, from about 9 am 10 am. Inspection by Hubert Philoctete and Paul Wierzbicki. Photo taken by Paul Wierzbicki. 46 photos taken with Waste Cleanup Olympus Digital Camera. Met Philip Cook, P.G. and Mr. Jeff Hooper on site. View looking roughly in the Northerly direction across 3 parcels of property. 3460 NW North River Drive, 3450 NW North River Dr. and an adjacent parcel to the Northeast. Mr. Hooper explained that the large blue-colored garage door was the Pure Lead Products Facility. Building with sliding garage door was reportedly built in 1939 per Prop. Appraisers Office Website. The wall and crane belongs to 3440 NW North River Dr. Photo 15 of 46.

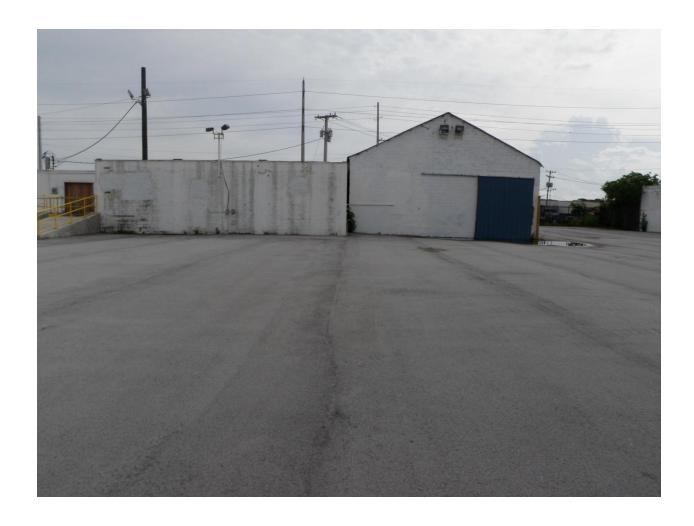
Pure Lead Products (former), Miami, Miami-Dade County, FL, Wednesday, May 19, 2010, from about 9 am 10 am. Inspection by Hubert Philoctete and Paul Wierzbicki. Photo taken by Paul Wierzbicki. 46 photos taken with Waste Cleanup Olympus Digital Camera. Met Philip Cook, P.G. and Mr. Jeff Hooper on site. View looking roughly Northeast toward 3 properties. Note that the property lines are not obvious. Photo 16 of 46.

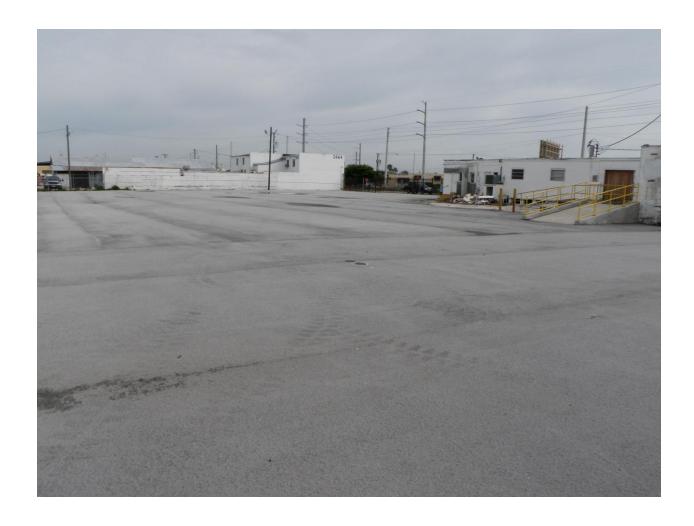
Pure Lead Products (former), Miami, Miami-Dade County, FL, Wednesday, May 19, 2010, from about 9 am 10 am. Inspection by Hubert Philoctete and Paul Wierzbicki. Photo taken by Paul Wierzbicki. 46 photos taken with Waste Cleanup Olympus Digital Camera. Met Philip Cook, P.G. and Mr. Jeff Hooper on site. Photo looking north toward 3464 NW North River Drive. Note Monitoring Wells in approximate center of photograph and pavement / storm drains. Also note that property lines are not obvious and not defined on the paved area. Photo 17 of 46.

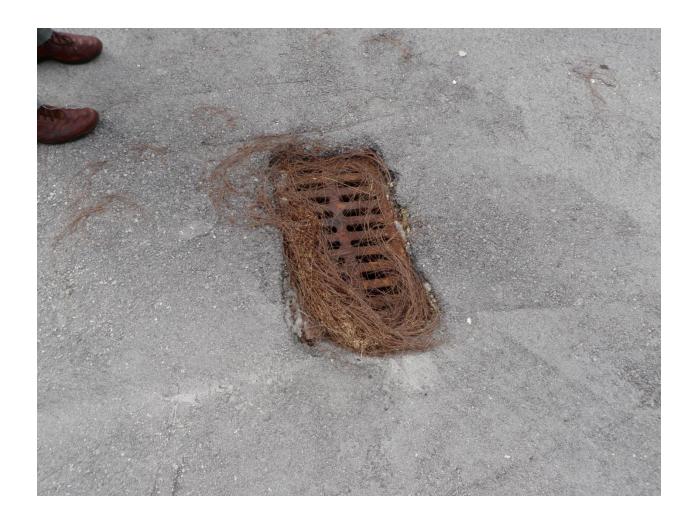
Pure Lead Products (former), Miami, Miami-Dade County, FL, Wednesday, May 19, 2010, from about 9 am 10 am. Inspection by Hubert Philoctete and Paul Wierzbicki. Photo taken by Paul Wierzbicki. 46 photos taken with Waste Cleanup Olympus Digital Camera. Met Philip Cook, P.G. and Mr. Jeff Hooper on site. Close up view of storm drain east of Pure Lead Products, on land defined as "Vacant Land" on property appraiser's office. Drain is clogged with pine needles. Photo 19 of 46.

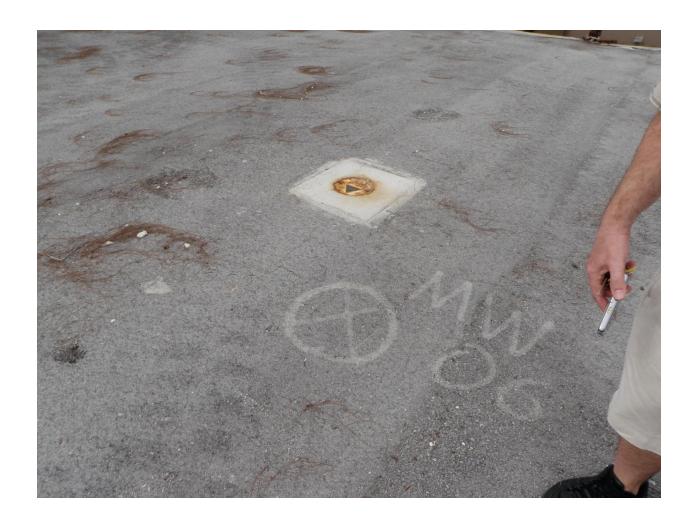
Pure Lead Products (former), Miami, Miami-Dade County, FL, Wednesday, May 19, 2010, from about 9 am 10 am. Inspection by Hubert Philoctete and Paul Wierzbicki. Photo taken by Paul Wierzbicki. 46 photos taken with Waste Cleanup Olympus Digital Camera. Met Philip Cook, P.G. and Mr. Jeff Hooper on site. Close up view of Monitoring Well 6. Mr. Hooper appears on right side of photo. Photo 20 of 46.

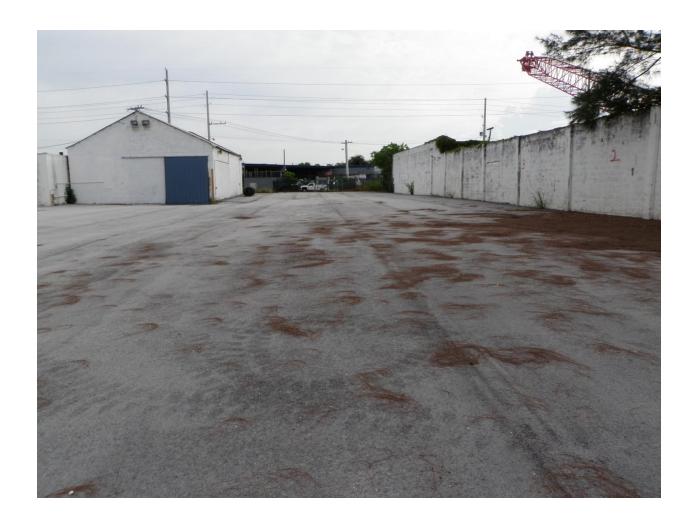
Pure Lead Products (former), Miami, Miami-Dade County, FL, Wednesday, May 19, 2010, from about 9 am 10 am. Inspection by Hubert Philoctete and Paul Wierzbicki. Photo taken by Paul Wierzbicki. 46 photos taken with Waste Cleanup Olympus Digital Camera. Met Philip Cook, P.G. and Mr. Jeff Hooper on site. Looking Northeast toward NW North River Drive. Gate to the property is in the distance, along with the active Railroad track. Building on the left side of photo is Pure Lead Products. The "Vacant Land" to the right of the building also was Pure Lead Products, per Mr. Hooper. Note that the property lines are not obvious. Wall on right side of photo belongs to 3440 NW North River Dr., per Mr. Hooper. Photo 23 of 46.

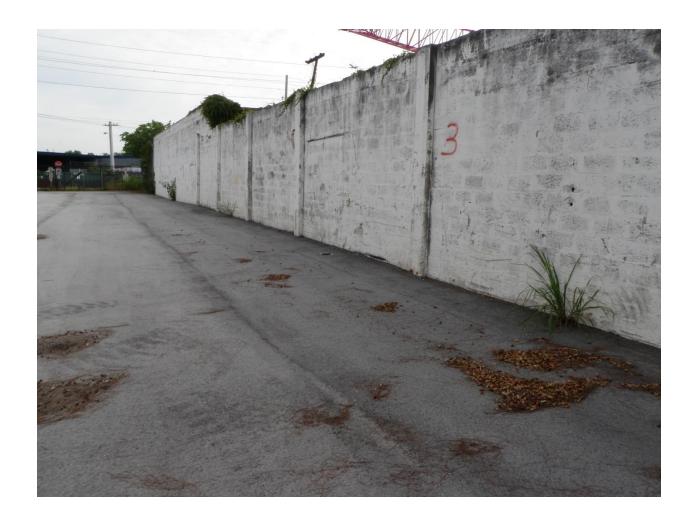
Pure Lead Products (former), Miami, Miami-Dade County, FL, Wednesday, May 19, 2010, from about 9 am 10 am. Inspection by Hubert Philoctete and Paul Wierzbicki. Photo taken by Paul Wierzbicki. 46 photos taken with Waste Cleanup Olympus Digital Camera. Met Philip Cook, P.G. and Mr. Jeff Hooper on site. Looking Northeast. From "Vacant Lot" of Pure Lead Products operation. Another Entry / Gate and railroad is at the far side of the photo. Per Mr. Hooper wall belongs to 2440 NW North River Dr. Photo 24 of 46.

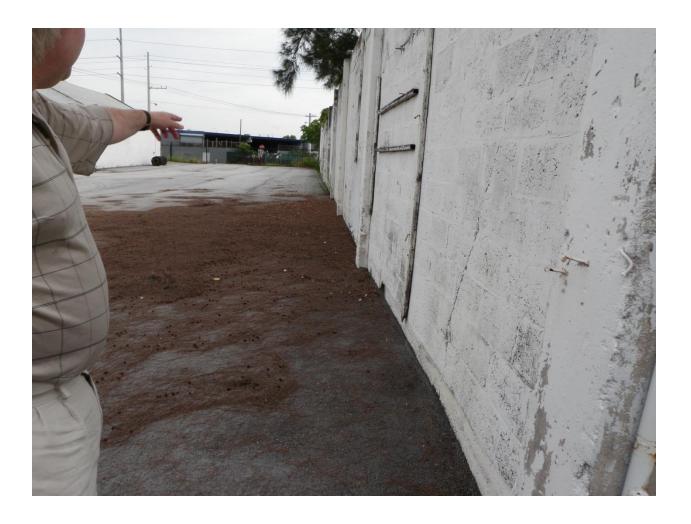
Pure Lead Products (former), Miami, Miami-Dade County, FL, Wednesday, May 19, 2010, from about 9 am 10 am. Inspection by Hubert Philoctete and Paul Wierzbicki. Photo taken by Paul Wierzbicki. 46 photos taken with Waste Cleanup Olympus Digital Camera. Met Philip Cook, P.G. and Mr. Jeff Hooper on site. Mr. Hooper points toward the Northeast toward another gate and railroad tracks and NW North River Drive beyond. Photo 26 of 46.

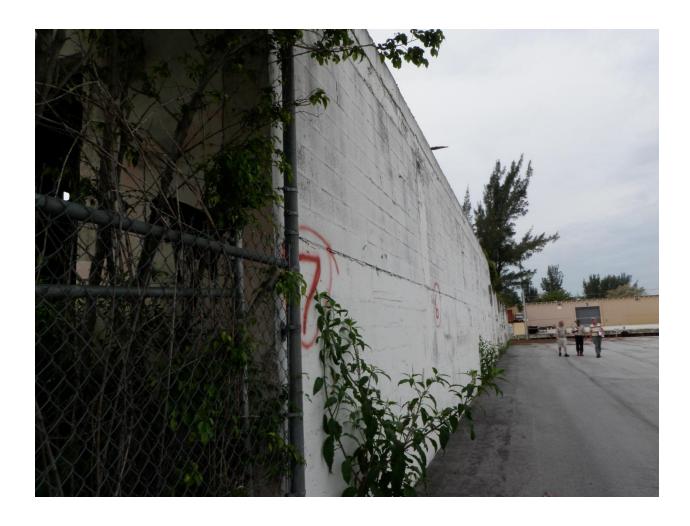
Pure Lead Products (former), Miami, Miami-Dade County, FL, Wednesday, May 19, 2010, from about 9 am 10 am. Inspection by Hubert Philoctete and Paul Wierzbicki. Photo taken by Paul Wierzbicki. 46 photos taken with Waste Cleanup Olympus Digital Camera. Looking Southwest toward Miami River on Pure Lead Products Site. Wall belongs to 3440 NW North River Dri. Open Garage door of 3440 is obscured by overgrown, dense vegetation at fence line. Photo 29 of 46.

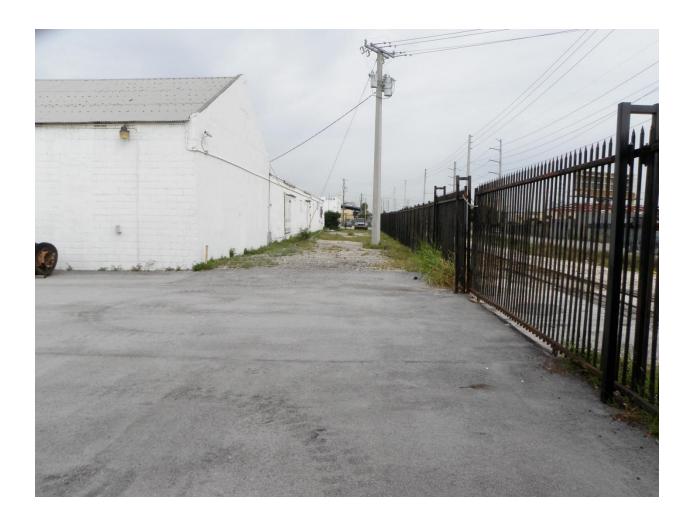
Pure Lead Products (former), Miami, Miami-Dade County, FL, Wednesday, May 19, 2010, from about 9 am 10 am. Inspection by Hubert Philoctete and Paul Wierzbicki. Photo taken by Paul Wierzbicki. 46 photos taken with Waste Cleanup Olympus Digital Camera. Looking Northwest from North East Corner of Pure Lead Products / 3440 NW North River Dr. Former Railroad siding ran along the buildings, per Mr. Hooper. Active railroad tracks and NW North River Dr. are beyond the fence and gate on the right side of photo. Gate serves Pure Lead Products operation. There are no obvious property boundaries. Looking across 5 separate properties. Photo 30 of 46.

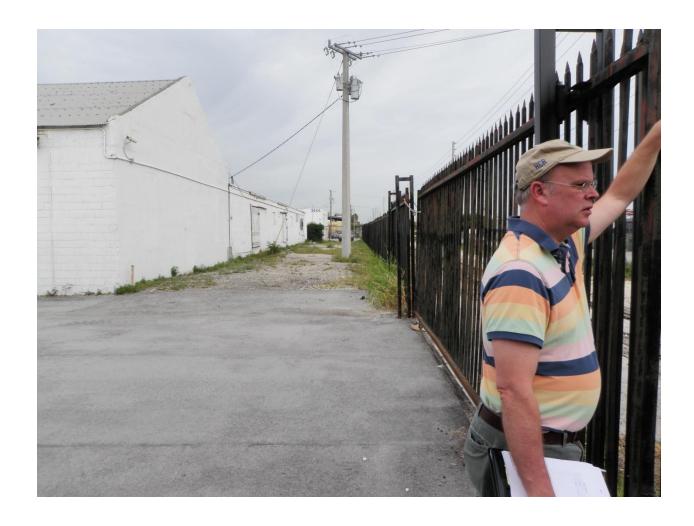
Pure Lead Products (former), Miami, Miami-Dade County, FL, Wednesday, May 19, 2010, from about 9 am 10 am. Inspection by Hubert Philoctete and Paul Wierzbicki. Photo taken by Paul Wierzbicki. 46 photos taken with Waste Cleanup Olympus Digital Camera. Looking in a Northwestern direction along fence line. Philip Cook appears on the right side of photo. Note bare ground areas in distance. Photo 31 of 46.

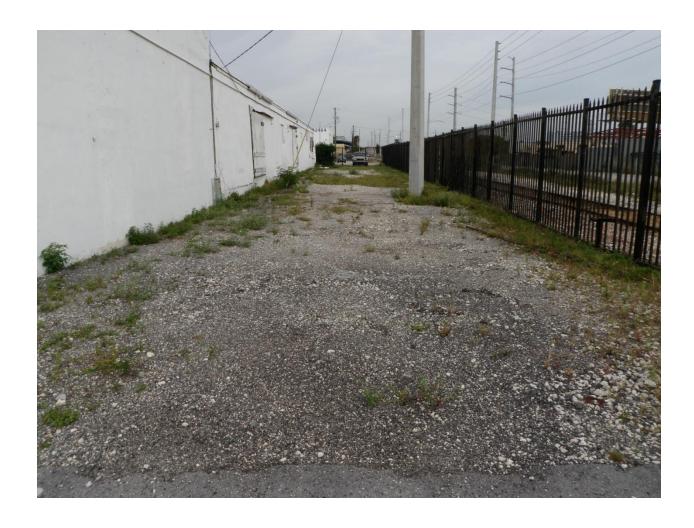
Pure Lead Products (former), Miami, Miami-Dade County, FL, Wednesday, May 19, 2010, from about 9 am 10 am. Inspection by Hubert Philoctete and Paul Wierzbicki. Photo taken by Paul Wierzbicki. 46 photos taken with Waste Cleanup Olympus Digital Camera. Looking Northwest along 3 properties along Northwest / Southeast fence line. A railroad spur served the buildings on the left side of photo, per Mr. Hooper. Note bare ground / gravel covered areas with little vegetation. Photo 33 of 46.

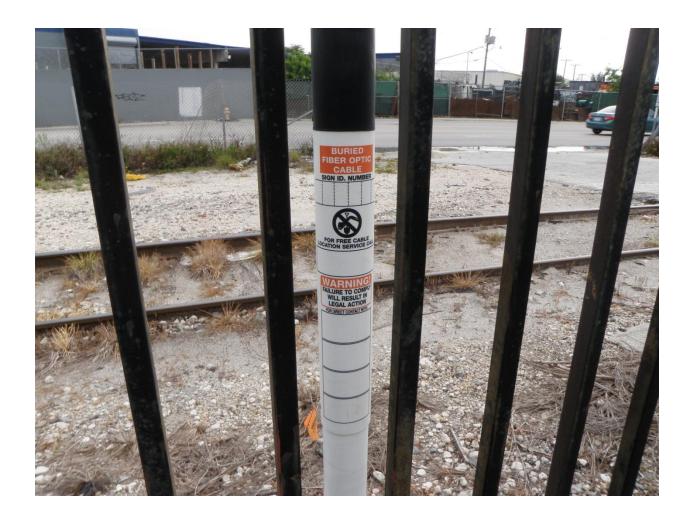
Pure Lead Products (former), Miami, Miami-Dade County, FL, Wednesday, May 19, 2010, from about 9 am 10 am. Inspection by Hubert Philoctete and Paul Wierzbicki. Photo taken by Paul Wierzbicki. 46 photos taken with Waste Cleanup Olympus Digital Camera. Close up of Warning Post along the active railroad tracks. Photo taken Northeast through the fence from the Pure Lead Products facility. Warning Post advises of "Buried Fiber Optic Cable". Photo 35 of 46.

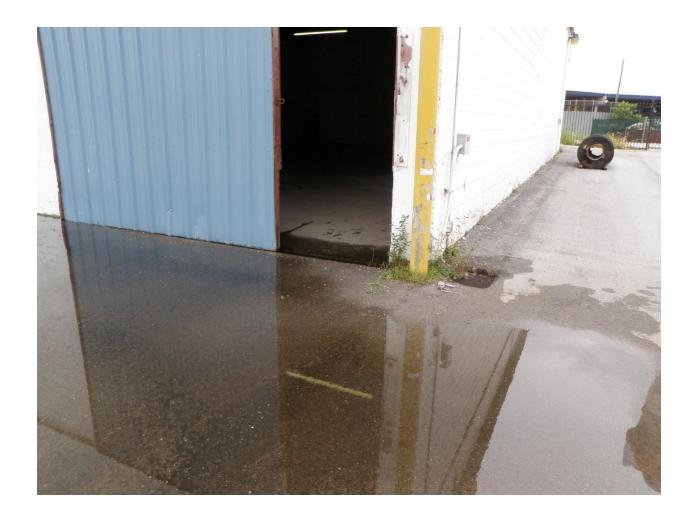
Pure Lead Products (former), Miami, Miami-Dade County, FL, Wednesday, May 19, 2010, from about 9 am 10 am. Inspection by Hubert Philoctete and Paul Wierzbicki. Photo taken by Paul Wierzbicki. 46 photos taken with Waste Cleanup Olympus Digital Camera. Mr. Hooper had the key to the garage door and opened it during the inspection. This is at the Southside of Pure Lead Products building. Standing water was observed at the garage door. Note that inside of the garage slopes toward the garage door opening. Looking approximately north. Photo 37 of 46.

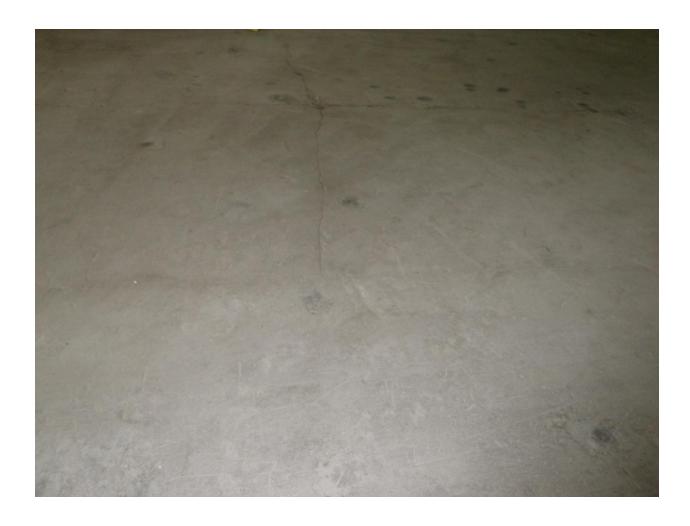
Pure Lead Products (former), Miami, Miami-Dade County, FL, Wednesday, May 19, 2010, from about 9 am 10 am. Inspection by Hubert Philoctete and Paul Wierzbicki. Photo taken by Paul Wierzbicki. 46 photos taken with Waste Cleanup Olympus Digital Camera. Floor cracks visible inside the building that was Pure Lead Products. Photo 38 of 46.

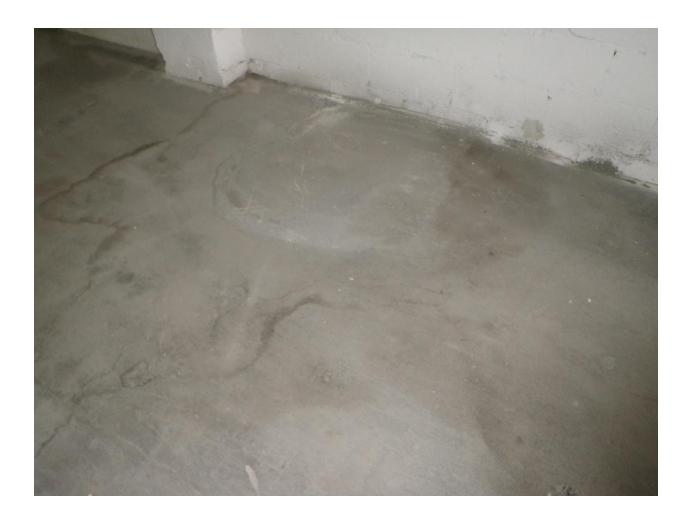
Pure Lead Products (former), Miami, Miami-Dade County, FL, Wednesday, May 19, 2010, from about 9 am 10 am. Inspection by Hubert Philoctete and Paul Wierzbicki. Photo taken by Paul Wierzbicki. 46 photos taken with Waste Cleanup Olympus Digital Camera. Note replacement concrete and floor cracks along the South wall of the Pure Lead Products Building. Photo 39 of 46.

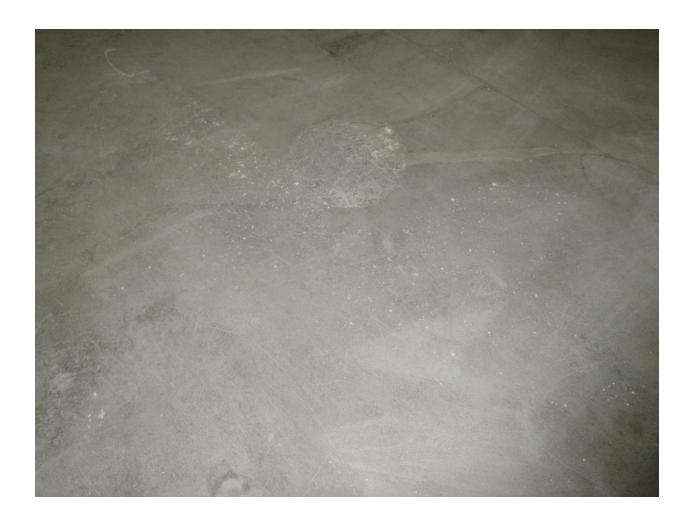
Pure Lead Products (former), Miami, Miami-Dade County, FL, Wednesday, May 19, 2010, from about 9 am 10 am. Inspection by Hubert Philoctete and Paul Wierzbicki. Photo taken by Paul Wierzbicki. 46 photos taken with Waste Cleanup Olympus Digital Camera. Note replacement concrete and floor cracks inside of the Pure Lead Products Building. Photo 40 of 46.

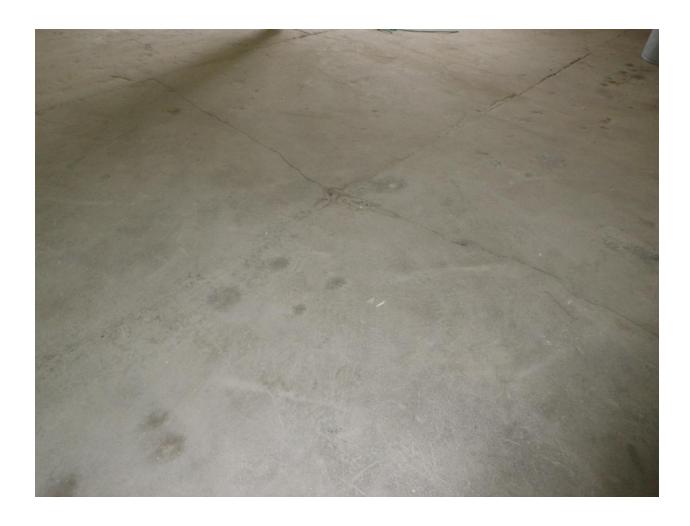
Pure Lead Products (former), Miami, Miami-Dade County, FL, Wednesday, May 19, 2010, from about 9 am 10 am. Inspection by Hubert Philoctete and Paul Wierzbicki. Photo taken by Paul Wierzbicki. 46 photos taken with Waste Cleanup Olympus Digital Camera. Note cracks on the floor inside of the Pure Lead Products Building. Photo 41 of 46.

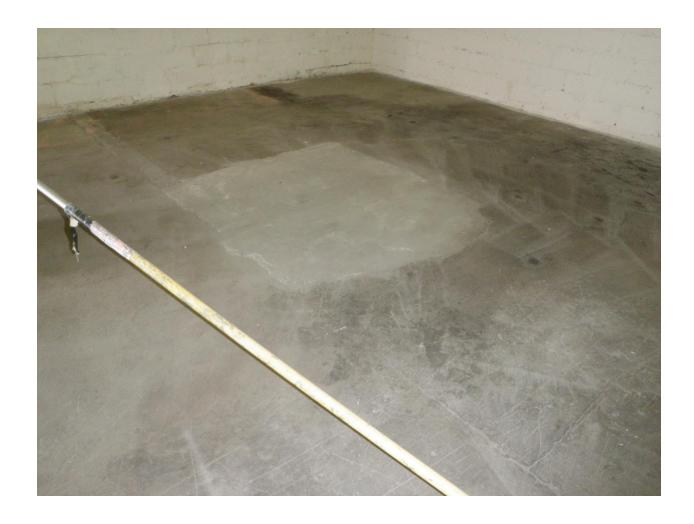
Pure Lead Products (former), Miami, Miami-Dade County, FL, Wednesday, May 19, 2010, from about 9 am 10 am. Inspection by Hubert Philoctete and Paul Wierzbicki. Photo taken by Paul Wierzbicki. 46 photos taken with Waste Cleanup Olympus Digital Camera. Note replacement concrete and floor cracks inside of the Pure Lead Products Building. Photo 42 of 46.

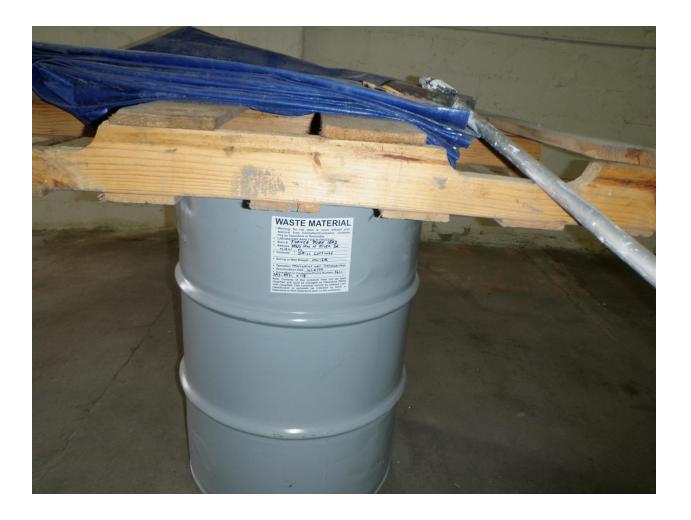
Pure Lead Products (former), Miami, Miami-Dade County, FL, Wednesday, May 19, 2010, from about 9 am 10 am. Inspection by Hubert Philoctete and Paul Wierzbicki. Photo taken by Paul Wierzbicki. 46 photos taken with Waste Cleanup Olympus Digital Camera. Drum and pallets stored inside of Pure Lead Products building. Drum is labeled with the Words "Waste Material", "Drill Cuttings", "3460 NW North River Drive", dated "10-14-2009". Photo 43 of 46.

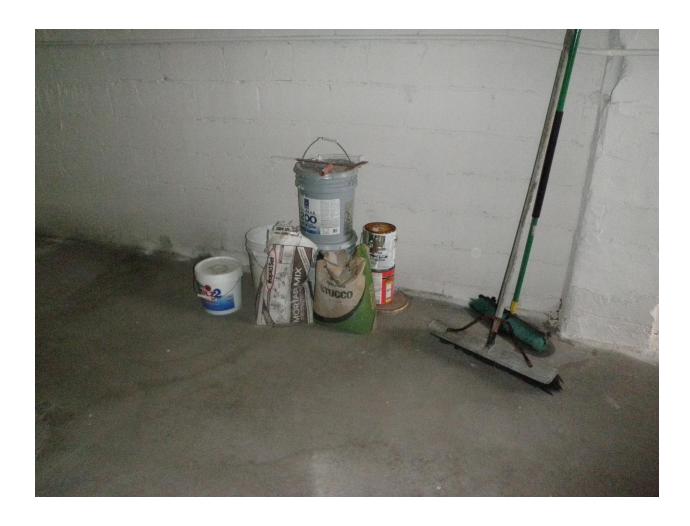
Pure Lead Products (former), Miami, Miami-Dade County, FL, Wednesday, May 19, 2010, from about 9 am 10 am. Inspection by Hubert Philoctete and Paul Wierzbicki. Photo taken by Paul Wierzbicki. 46 photos taken with Waste Cleanup Olympus Digital Camera. Containers of usable paint and related products stored inside the Pure Lead Products facility. Photo 44 of 46.

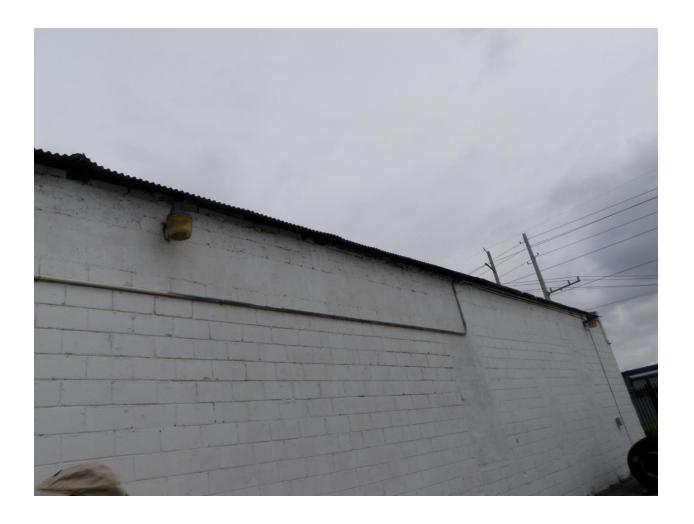
Pure Lead Products (former), Miami, Miami-Dade County, FL, Wednesday, May 19, 2010, from about 9 am 10 am. Inspection by Hubert Philoctete and Paul Wierzbicki. Photo taken by Paul Wierzbicki. 46 photos taken with Waste Cleanup Olympus Digital Camera. Outside South wall of former Pure Lead Products building. Note metal roof structure without drain gutters. Power lines along NW North River Drive are visible in background of photo. Photo 45 of 46.
